RE: Structural Assessment of Existing Old Wadsworth Gym Building  
200 School St, Wadsworth, NV  
Washoe County APN 084-200-37

Linchpin Project No. 23-128

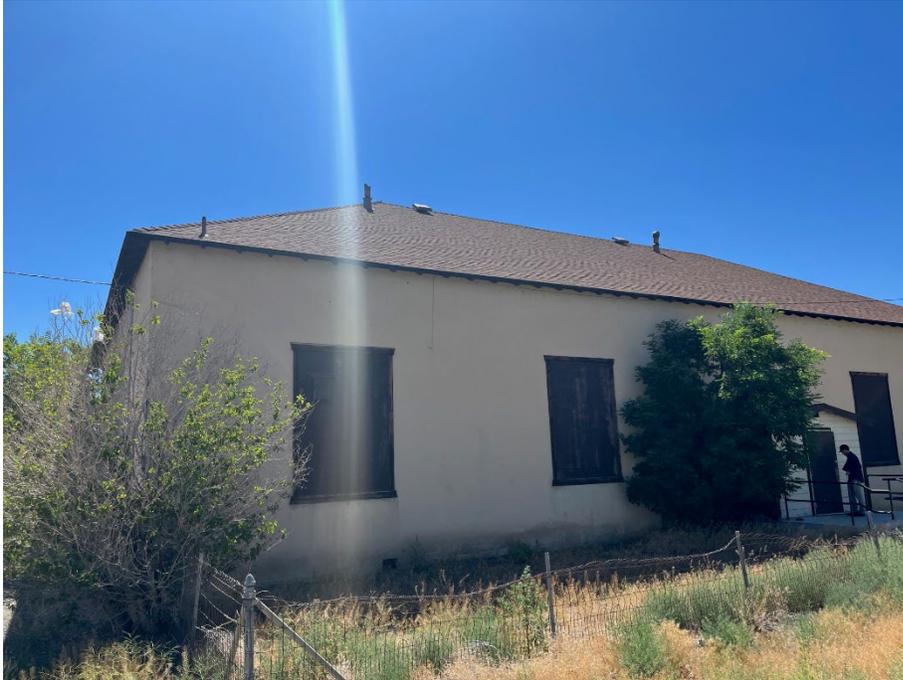
The gymnasium building is constructed of wood framed walls with a wood trussed roof. The roof is hipped at the corners with a center ridge between the hips. The wood roof trusses are spaced at 48" oc and clear span the gym floor creating the open floor of the gym. Photo 1 below shows the exterior of the building and photo 2 shows the interior of the gymnasium. The wall sheathing for the building consists of ¾" horizontal straight sheathing at interior and exterior face of wall. There are minimal openings in the exterior walls of the building which means that there appears to be adequate lateral resistance for the building.

Photo 1: Exterior of the Building

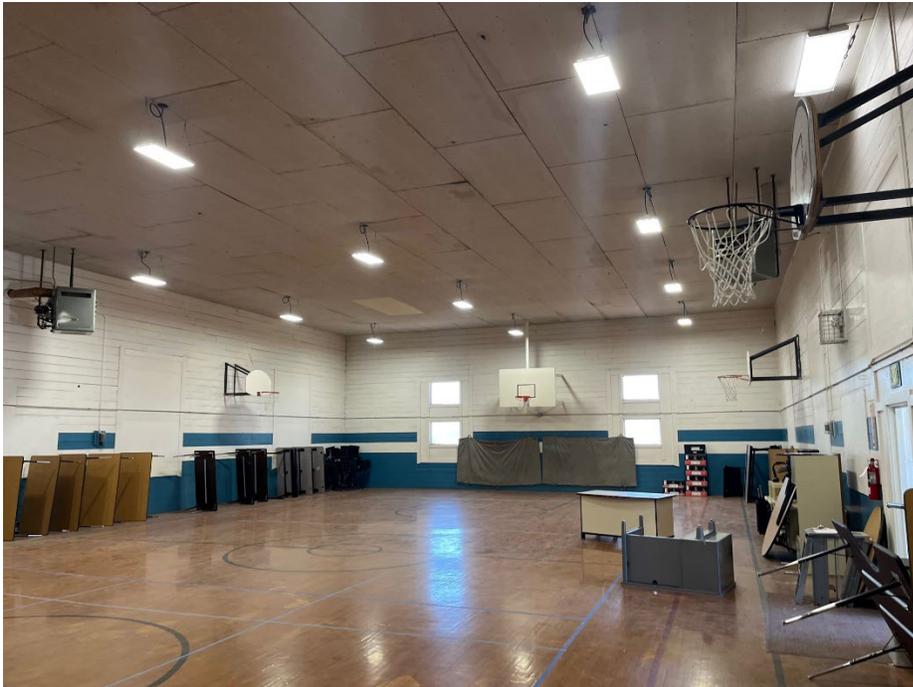
There does seem to be some evidence of roof leaks in the past as visible from the water stains on the ceiling in photo 2 below. I am not aware if these roof leaks have been fixed or not. There are also some cracks in the exterior stucco as seen in photo 7. These cracks are cosmetic and are not a structural concern.

Photo 2: Interior of the Gymnasium

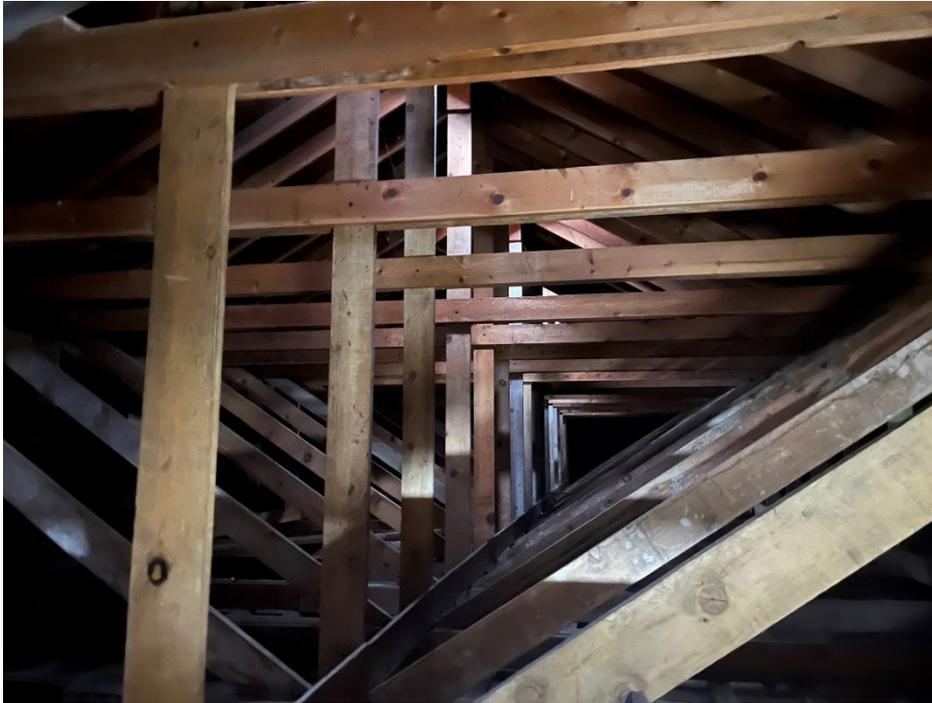
We were able to observe the wood trusses near the ceiling access above the stage. The trusses appeared to be in good condition, photo 3 shows the roof trusses that free span across the gymnasium. There is a stage with a crawl space below. We were able to observe the framing below the stage which appeared to be in good condition. Photo 4 shows the framing of the crawl space. The foundation of the exterior wall was visible from the crawl space below the stage and is shown in photo 5. The foundation that is accessible seems to be in good condition. The floor of the gymnasium does appear to be a raised framed floor but we could not find access to the crawl space below the floor so we could not observe the condition of the framing for the gymnasium floor.

Photo 3: Roof trusses spanning across gymnasium

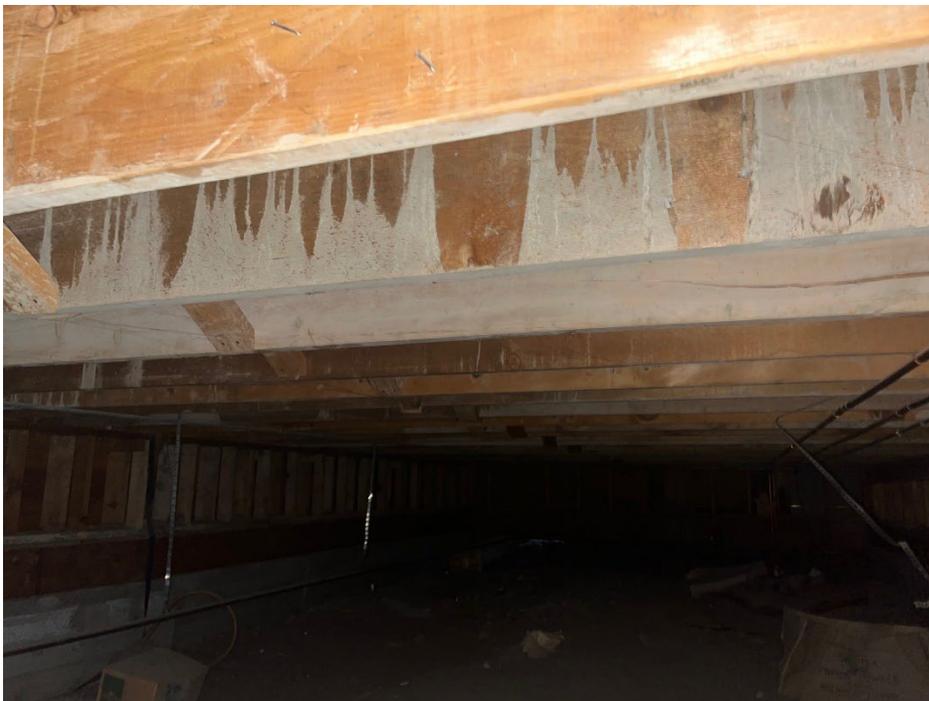
Photo 4: Crawl space below the stage

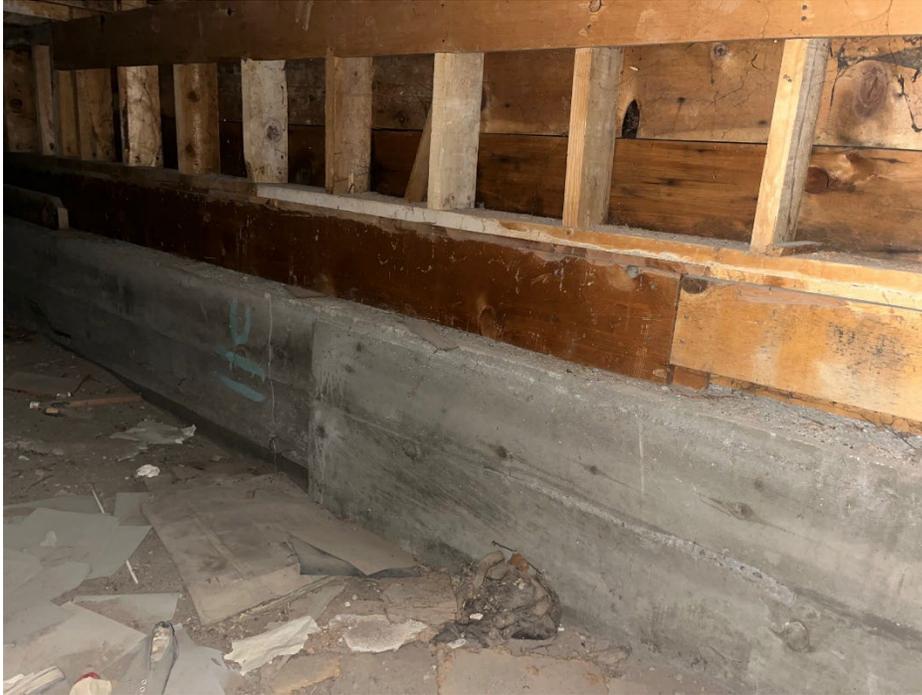
Photo 5: Foundation below exterior wall

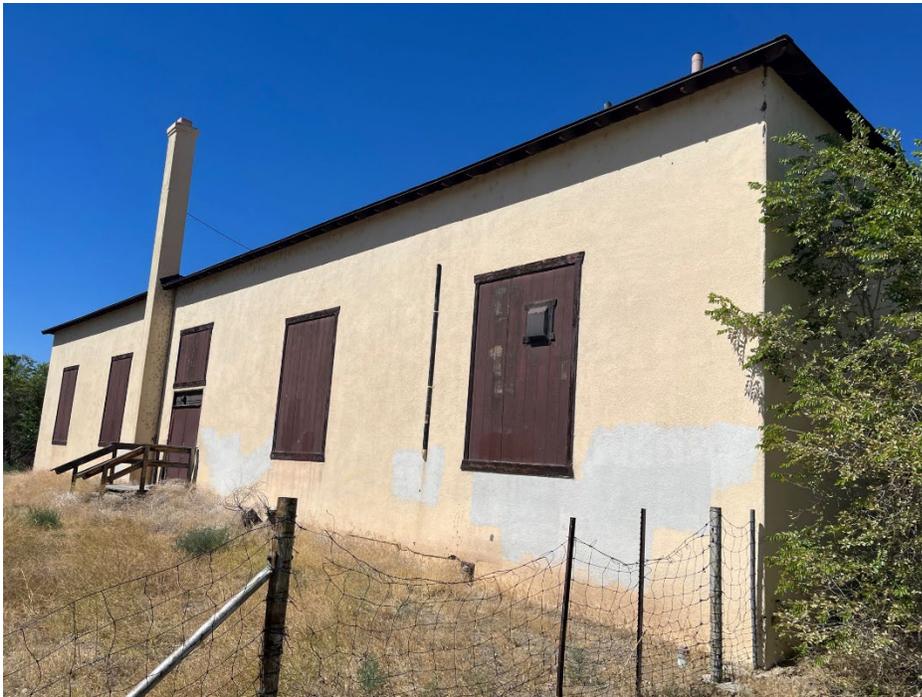
There is a tall chimney on the east side of the building. It appears that the chimney is constructed of wood framing, therefore, there is not a concern with collapse of the chimney in a seismic event that a brick chimney would present. Photo 6 shows the tall chimney on the east side of the building.

Photo 6: Chimney on east side of building

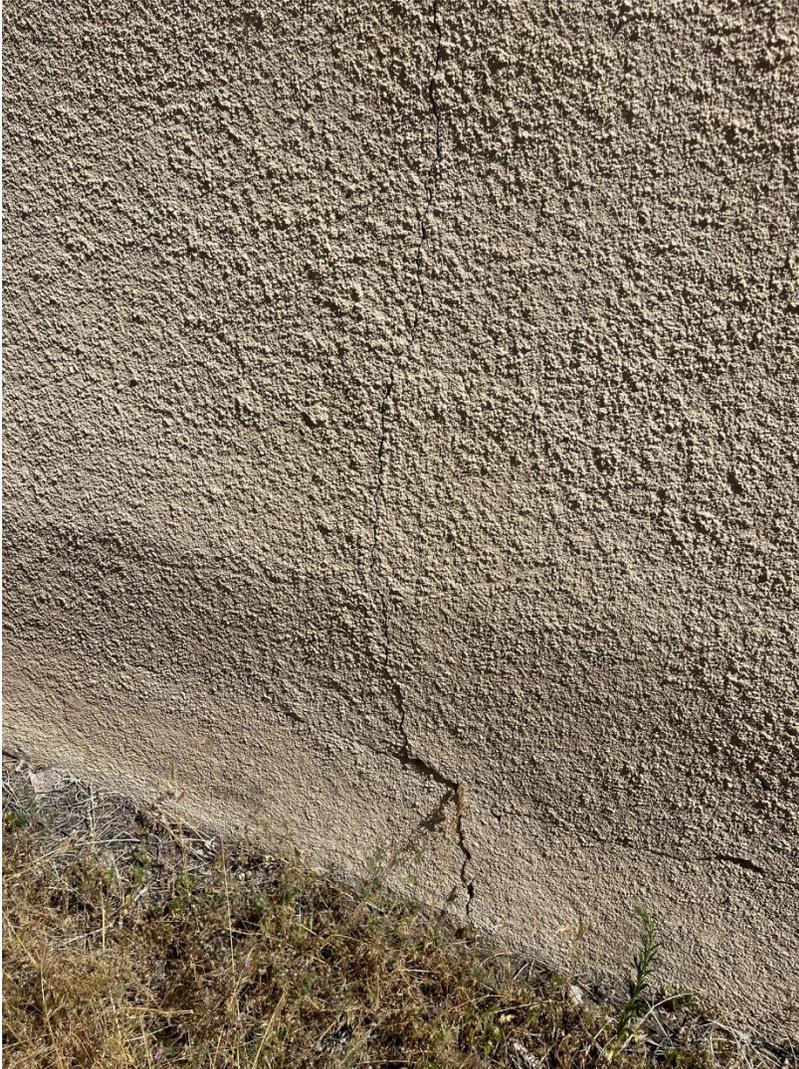
Photo 7: Cracks in exterior stucco
