ANALYSIS OF BROWNFIELD CLEANUP ALTERNATIVES

Urrutia Site

Wadsworth, NV 89442

Prepared by the Pyramid Lake Paiute Tribe's Tribal Response Program

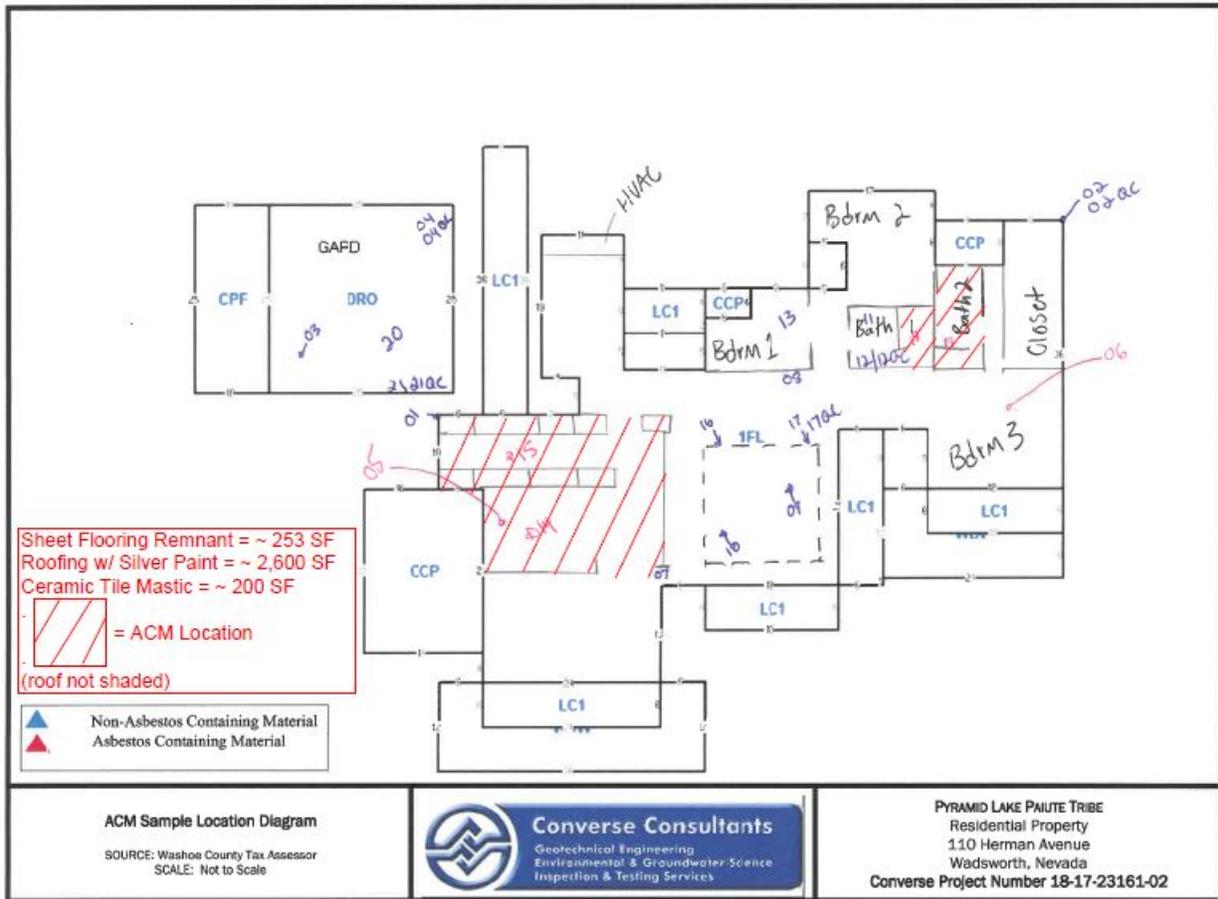
Figure 2:

Based on sampling results, the following ACMs were identified throughout the building: sheet vinyl (as part of the flooring remnant located in the kitchen, hallway, and laundry rooms), roof coating (on the roof located throughout the entire structures), and tile mastic/mortar (used as an adhesive for ceramic tiles located in two of the bathrooms).

Note: There is no guarantee that no further asbestos, beyond that which was suspected to be present (and sampled) during the Phase II ESA, is present at the site. Other ACMs may be uncovered during renovation or complete demolition. For a site map depicting locations where asbestos is present, please see Figure 2 on page 15.

Because ACMs would be disturbed during renovation and pose a health hazard, they should be removed prior to such an activity. Removal and disposal of ACMs should be undertaken by a licensed asbestos abatement contractor familiar with Nevada and federal regulations regarding asbestos.

Because ACMs would also be disturbed during complete demolition and pose a health hazard, they should be removed prior to such an activity. Removal and disposal of ACMs should be undertaken by a licensed asbestos abatement contractor familiar with Nevada and federal regulations regarding asbestos.

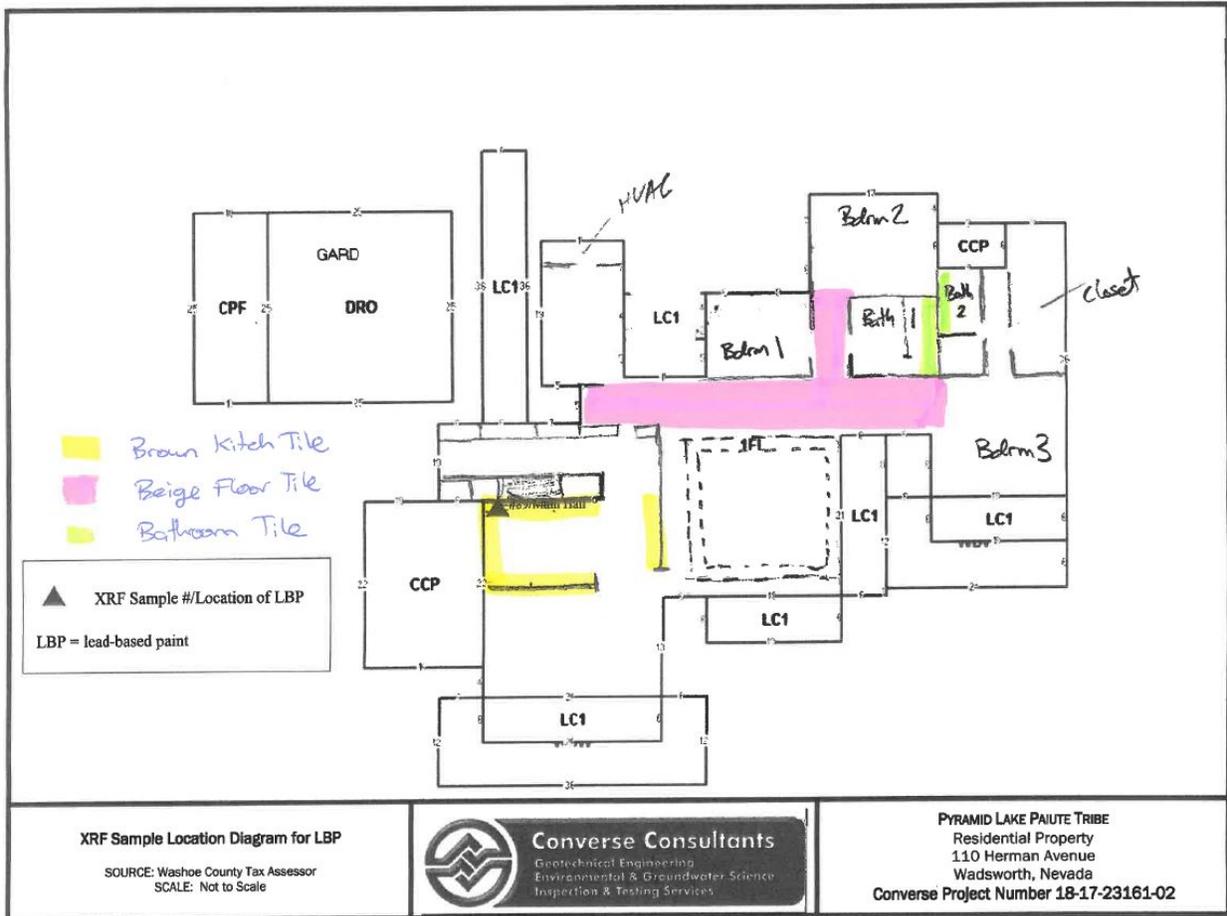
Figure 3:

XFR analyzer readings taken throughout the structures revealed that lead above health-based standards is present in ceramic tiles located in the kitchen and laundry room countertops, main hall floor, and Bathroom #1 and Bathroom #2 walls.

Note: Lead was found in ceramic tiles and not in paint (i.e., no LBP was found). This is important to consider as the action level for lead in paint differs from the action level for lead in other materials, such as tiles. For a site map depicting locations where lead is present, please see Figure 3 on page 16.

Because lead-containing materials would be disturbed during renovation and pose a health hazard, they should be removed prior to such an activity. Removal and disposal of lead-containing materials should be undertaken by a licensed lead abatement contractor familiar with Nevada and federal regulations regarding lead.

Note: The lead-containing ceramic tiles in Bathroom 1 and Bathroom 2 will be removed during ACM abatement. There should not be a need to handle such lead-containing ceramic tiles separately, as they may be disposed of along with the ACMs.

If a demolition firm with OSHA hazardous waste-trained personnel is used for complete demolition, dust suppression, particulate monitoring, personal protective equipment, and medical monitoring can be employed to eliminate the need to remove lead-containing ceramic tiles as a separate activity from complete demolition.
