Project No. 23-02-184

Re: Limited Asbestos and Lead-based Paint Inspection Report, Natchez Gym, 200 School St.,
Washoe County Assessor Parcel Number 084-200-37, Wadsworth, Nevada.

Asbestos and Lead-based Paint Inspection Report
Natchez Gym
200 School St.
Washoe County Assessor Parcel Number 084-200-37
Wadsworth, Nevada

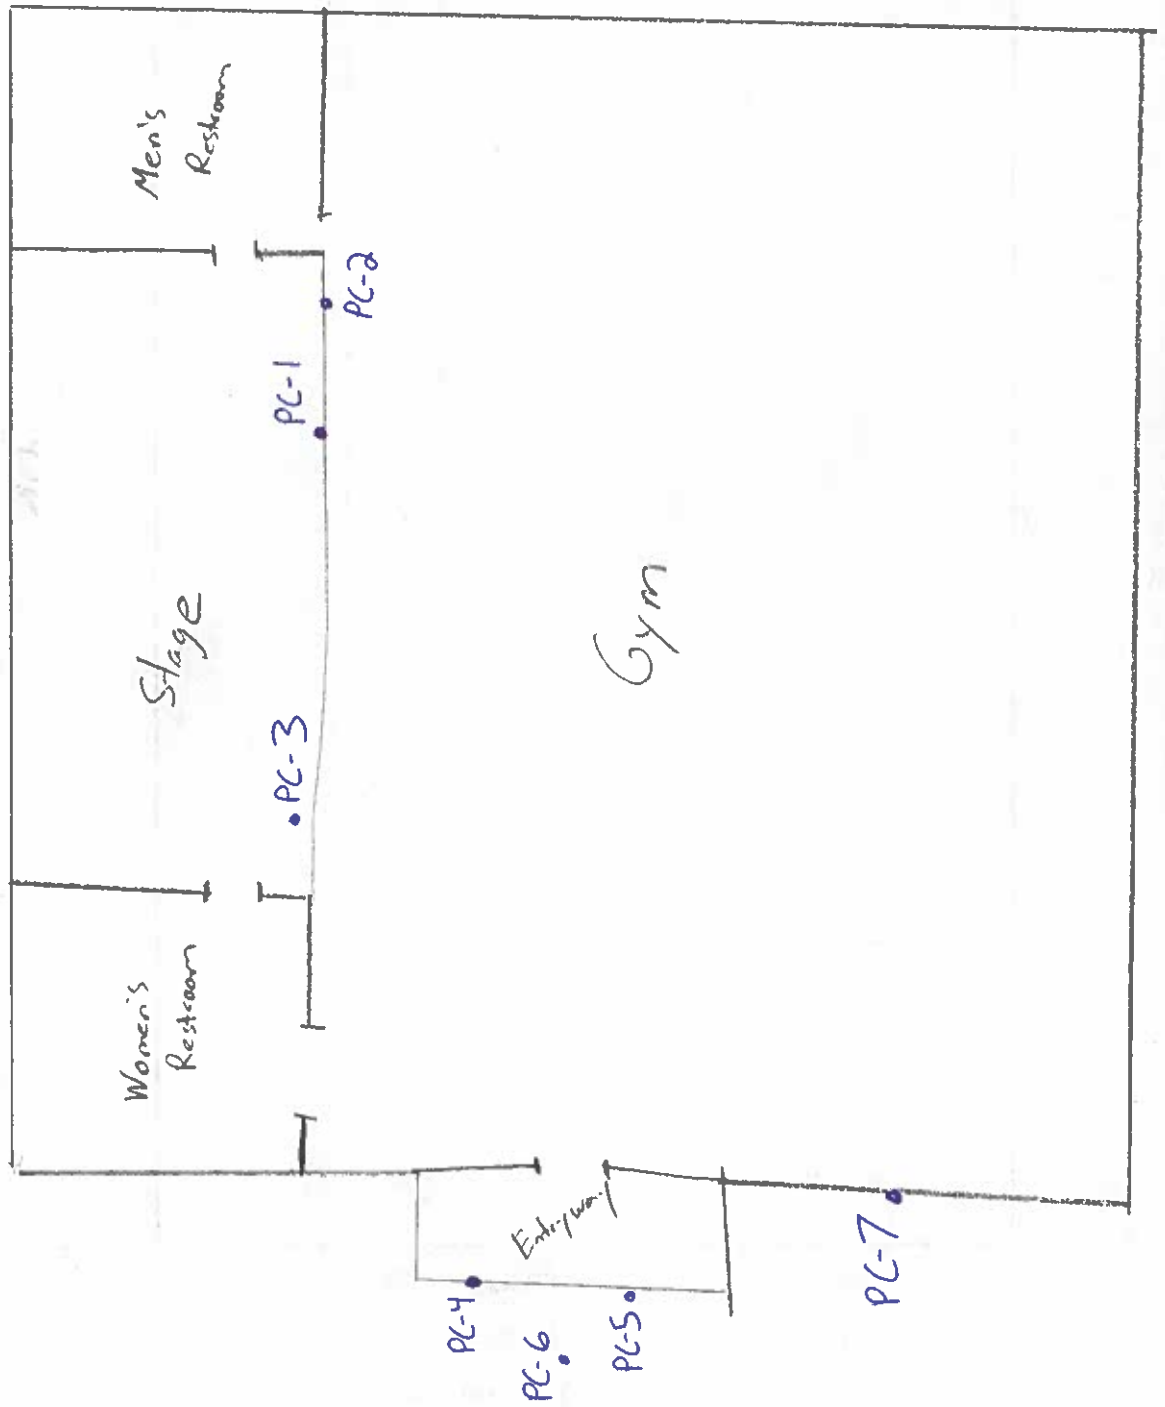
Figure 2: Sample Location Map
Lead Paint

Based on the analytical results of the samples collected during this inspection, LBP was not reported in any of the samples collected during this investigation. There is a possibility that additional suspect LBPs may be found during demolition activities that were not evaluated during this investigation. If suspect materials are identified during demolition activities, samples of these suspect materials should be collected and submitted for laboratory analysis. Any activities which may impact these suspect materials should cease until the completion of laboratory analysis. Suspect materials should be assumed to be hazardous and handled as such unless laboratory analysis has been performed.

Based on the analytical results of the samples collected during this inspection, LBP was not reported in any of the samples collected during this investigation. There is a possibility that additional suspect LBPs may be found during demolition activities that were not evaluated during this investigation. If suspect materials are identified during demolition activities, samples of these suspect materials should be collected and submitted for laboratory analysis. Any activities which may impact these suspect materials should cease until the completion of laboratory analysis. Suspect materials should be assumed to be hazardous and handled as such unless laboratory analysis has been performed.
